Confidential Property Report

A.C.C.S. PROPERTY INSPECTIONS

Tax Invoice: *2289*
CLIENT **Mandy Larsen**
PHONE: **0439 368079**
EMAIL: ***mandy/laesen@ccrc.qld.gov.au***
POSTAL ADDRESS
PROPERTY: **Mullens Hall Tully Showgrounds**
DATE: **26th September 2024**
WEATHER: **Fine**

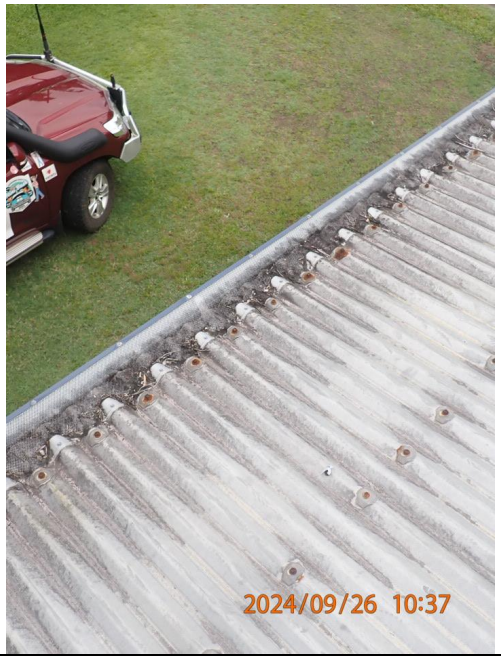
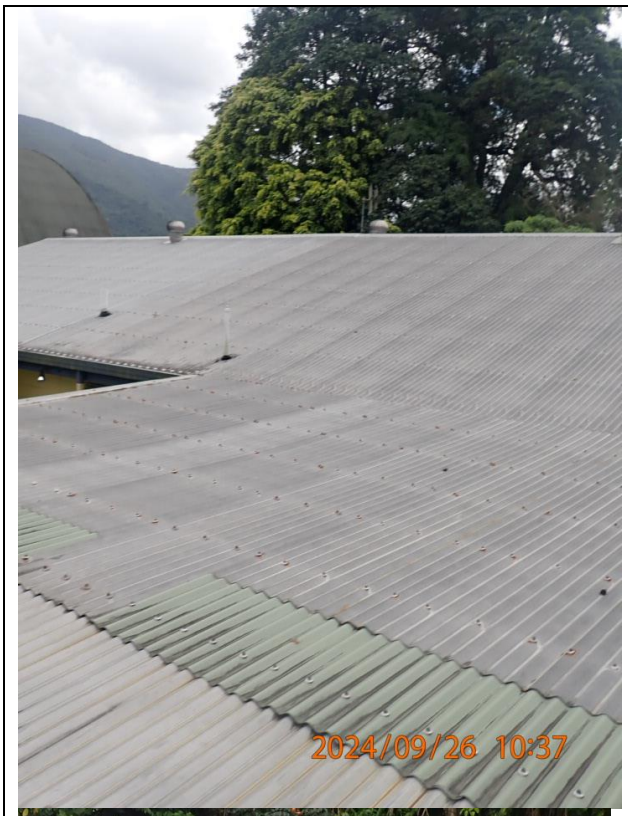
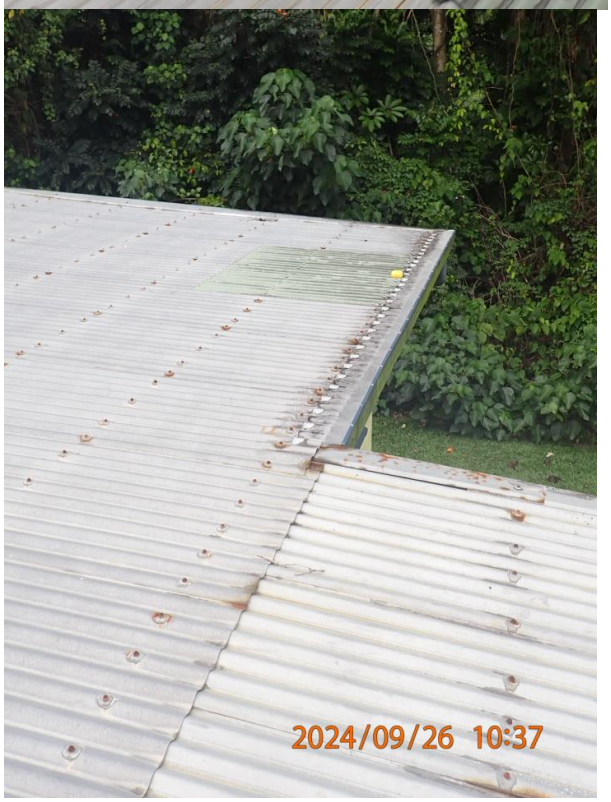
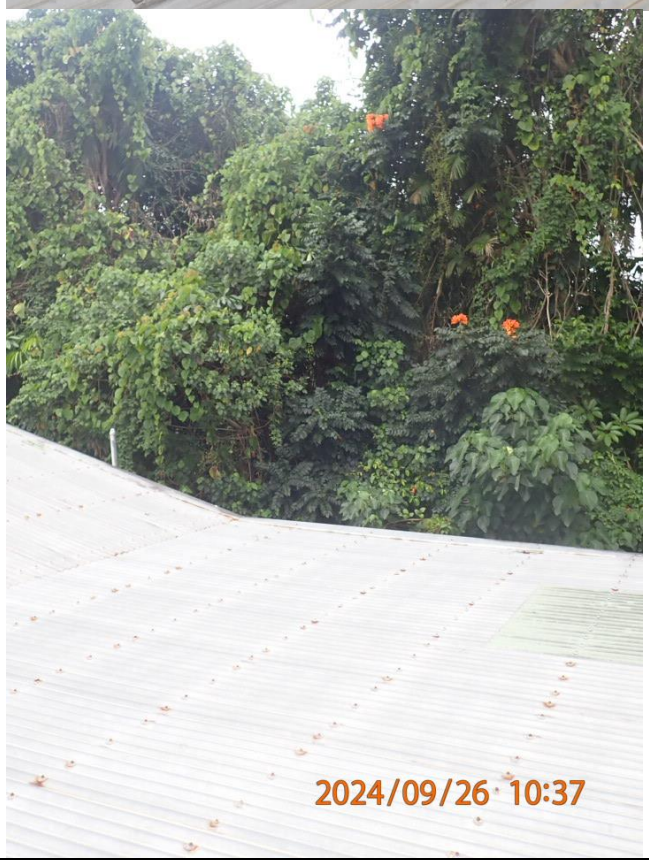
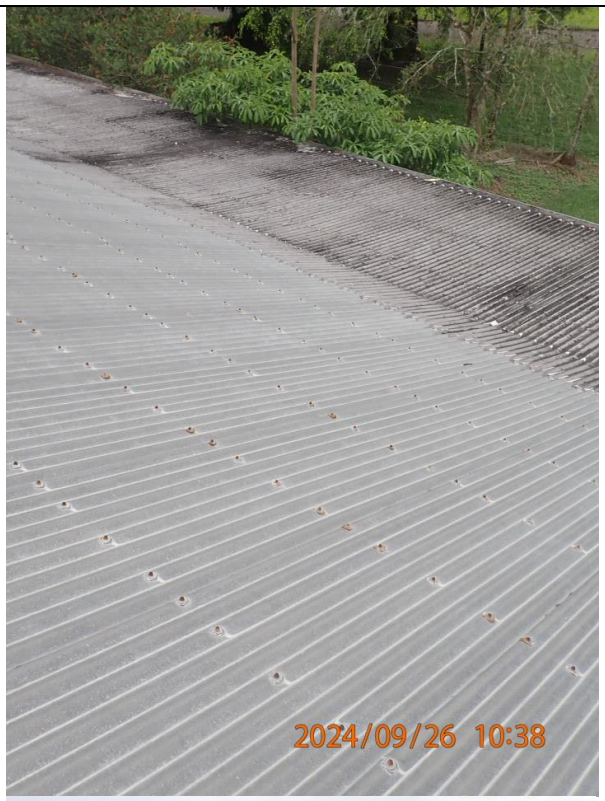
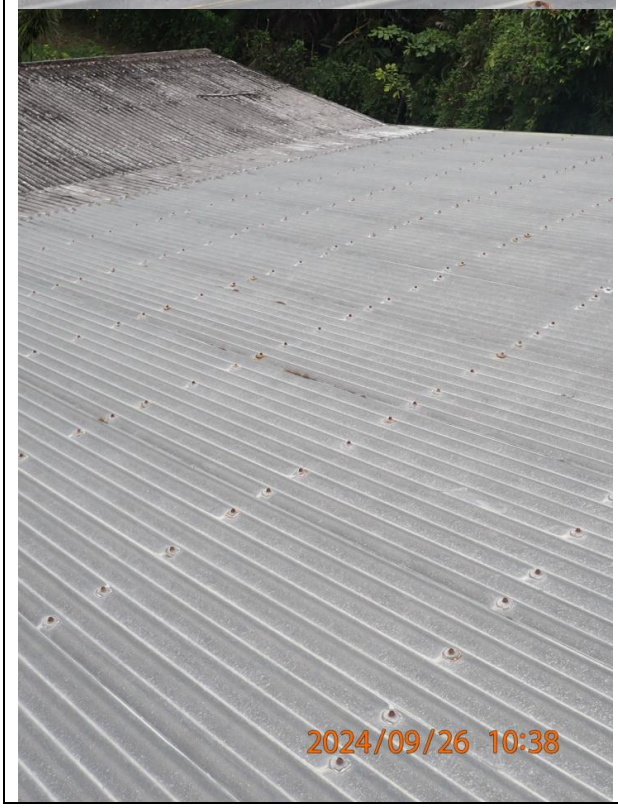
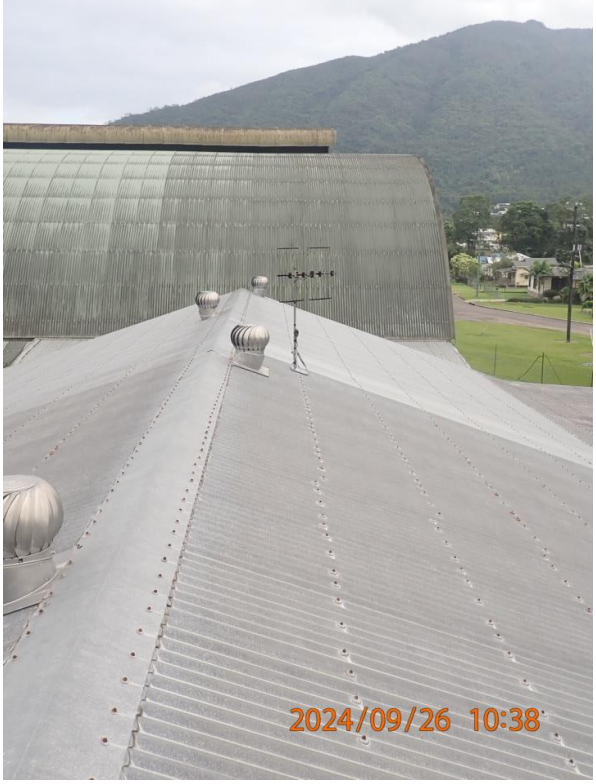
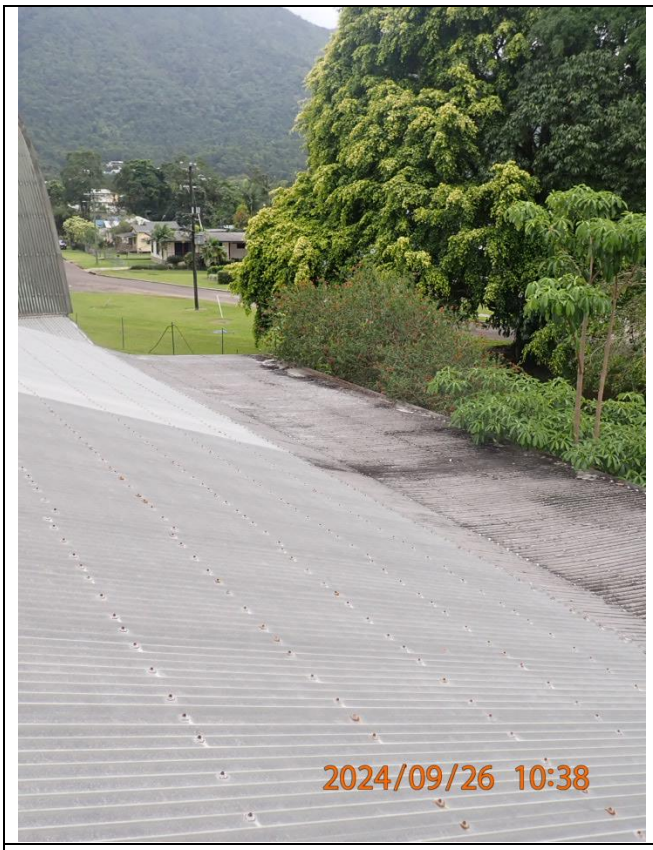
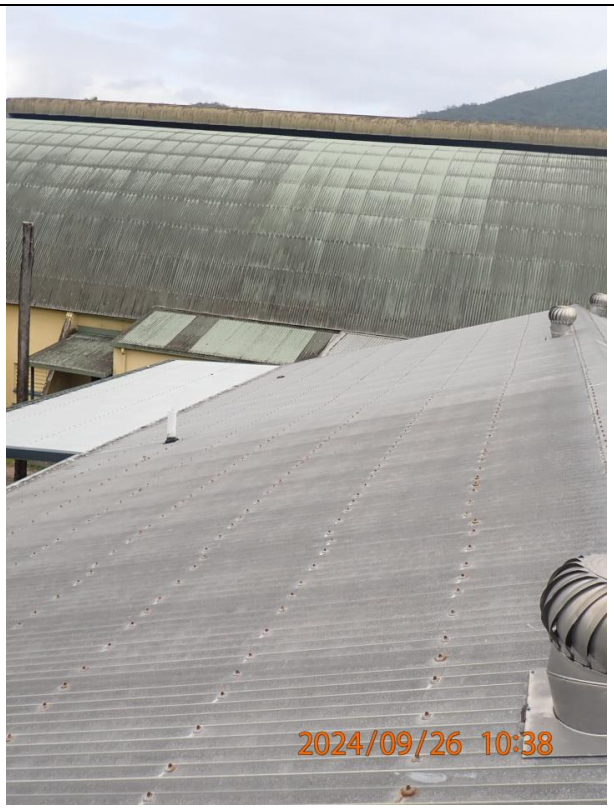
- Defect: rusting fixings and rust to laps and ends of roof sheeting
- Location: total roof area
- Recommendation: **Plumber** – Engage a suitably qualified plumber to provide rectification advice in accordance with AS/NZ 3500

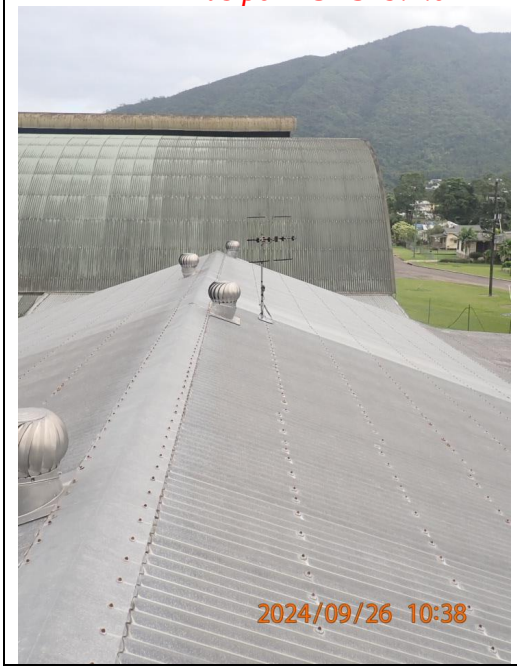
- Defect: rust to fixings
- Location: all
- Recommendation: **Plumber** – Engage a suitably qualified plumber to provide rectification advice in accordance with AS/NZ 3500

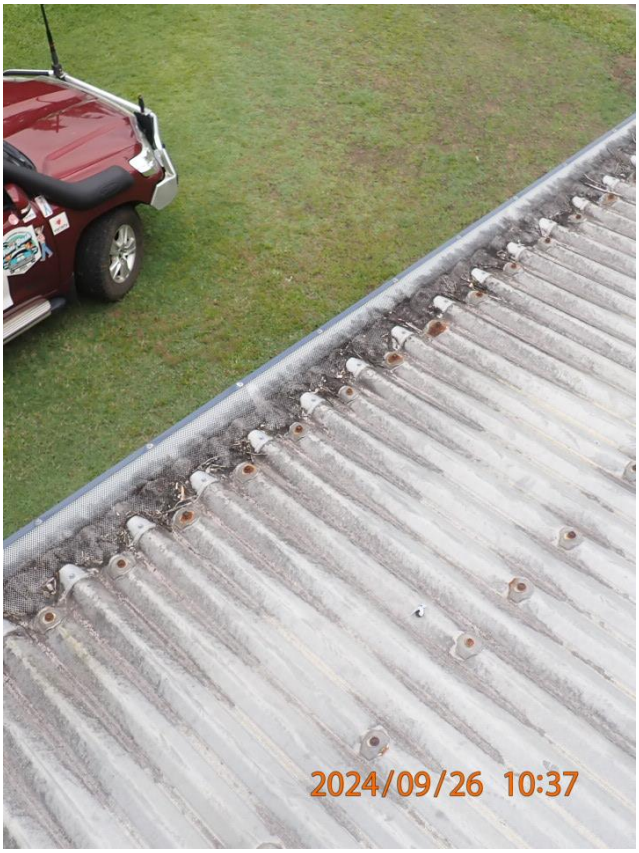
Gutters (visual only) Plumbing (Roof) *Note: ACCS inspectors are not qualified plumbers or Roofers, for a comprehensive report, a plumbing inspection on all Roofing and associated flashings etc. is recommended. We are not able to advise the condition of metal fascia behind gutters and roof sheeting laps or metal roof battens under roof insulation.* *as per AS 4349.1.07* 	• Defect: rust and deterioration • Location: all • Recommendation: **Plumber** – Engage a suitably qualified plumber to provide rectification advice in accordance with AS/NZ 3500

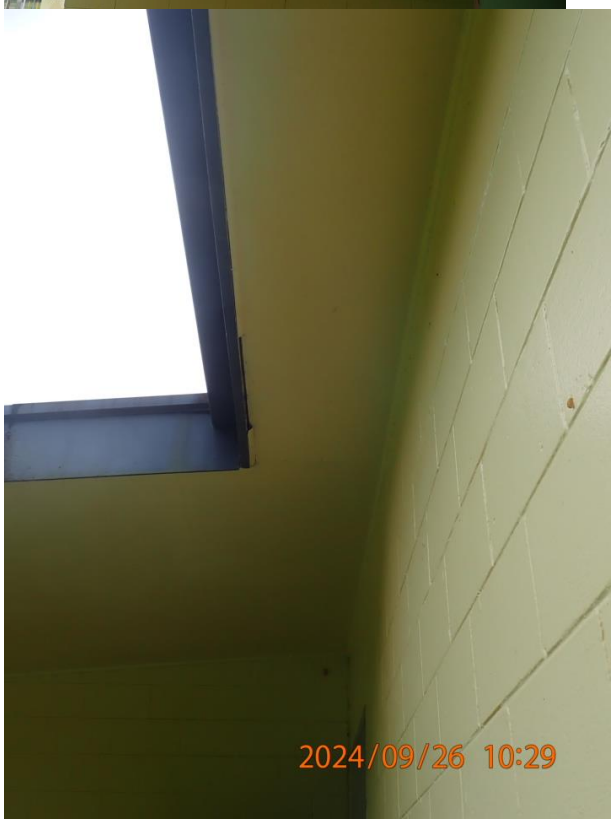
- Defect: deterioration
- Location: all
- Recommendation: repairs are recommended.
- **Plumber** – Engage a suitably qualified plumber to provide rectification advice in accordance with AS/NZ 3500
- **Recommendation: Carpenter** – engage a suitably qualified carpenter for rectification advice in accordance with A1684.

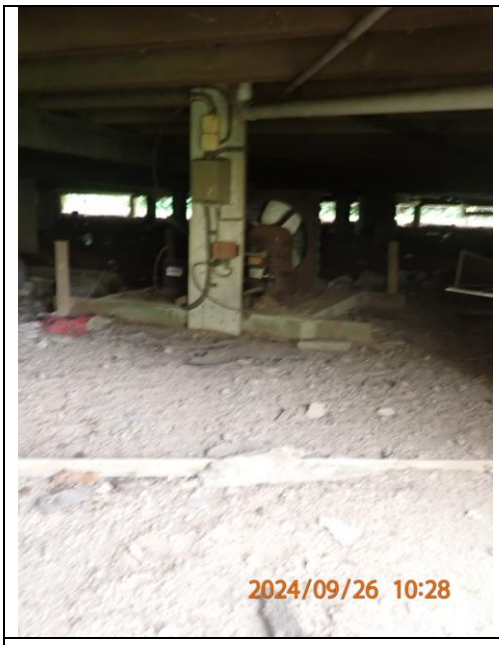
Under floor Areas	**Comments**
Tie Downs and metal items. *Recommend all bare metal items are treated and coated with a rust preventative*	• Visible rust to hold down bolts.
Termite Barriers (Any Caps etc.)	**Timber And Pest** – Seek advice from qualified and experienced professional in accordance with AS 3660.
Foundations (Visual above ground only	• As per stumps and supports
Stumps and support 	• Deteriorating to several concrete supports and repairs are recommended.

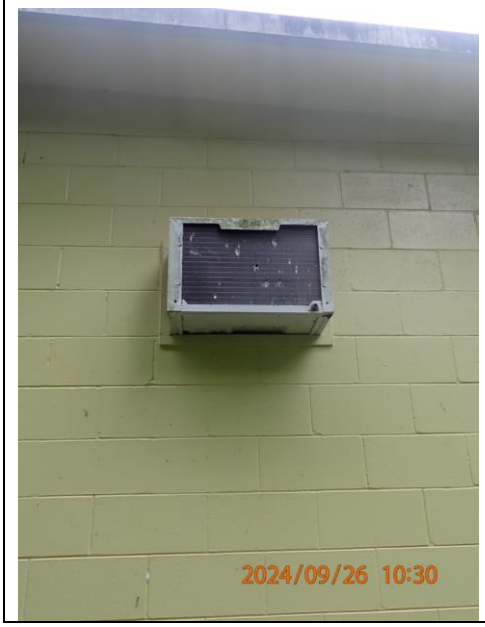
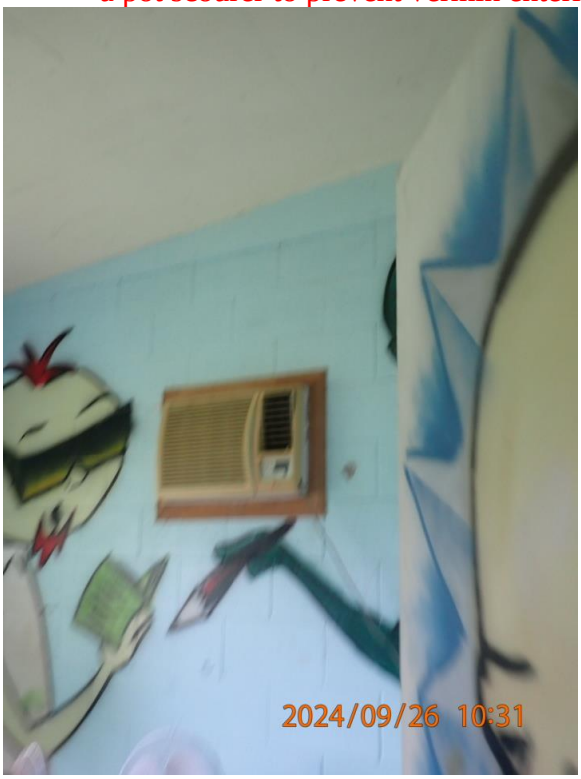
• Where installed generally appears to be in an acceptable condition with repairs required to frames. • Recommend Air conditioner drainpipe to be diverted to prevent deterioration to foundations. Visible rust to ac frame • Recommend Drainpipe to be plugged with a pot scourer to prevent vermin entering.

Bearers and Joists 	• Water appears is leaking in drainpipe.

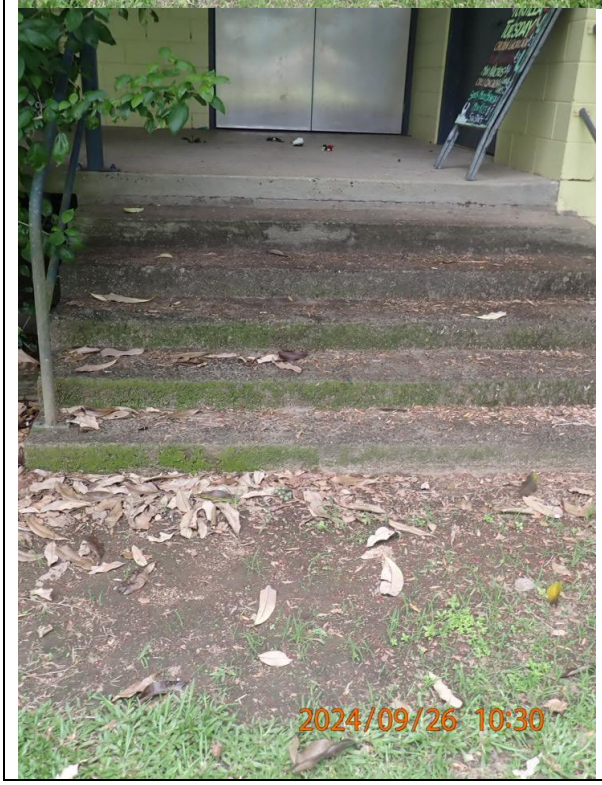
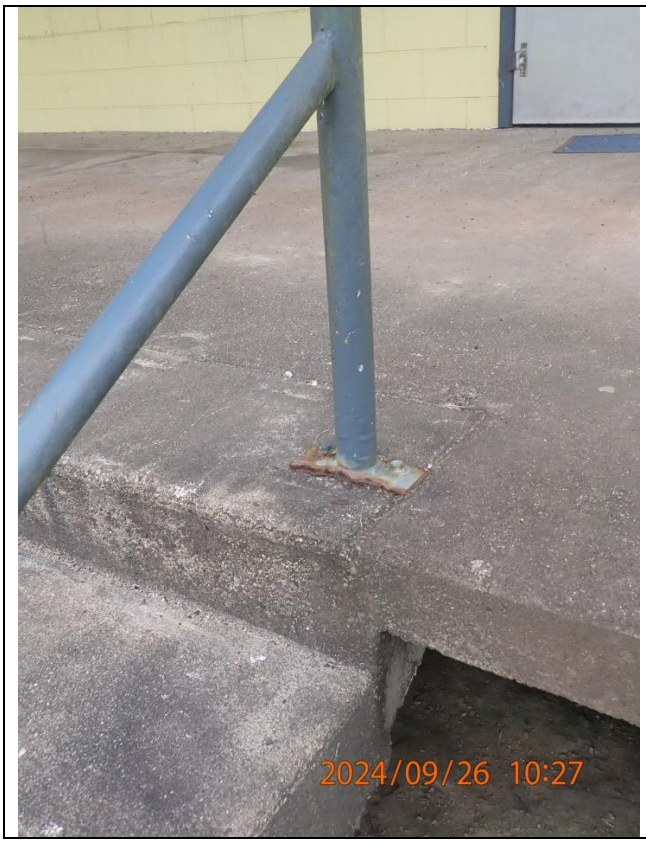
• Deterioration to tiles and top concrete steps to front and rear stairs and rust to hand rails and repairs are recommended.

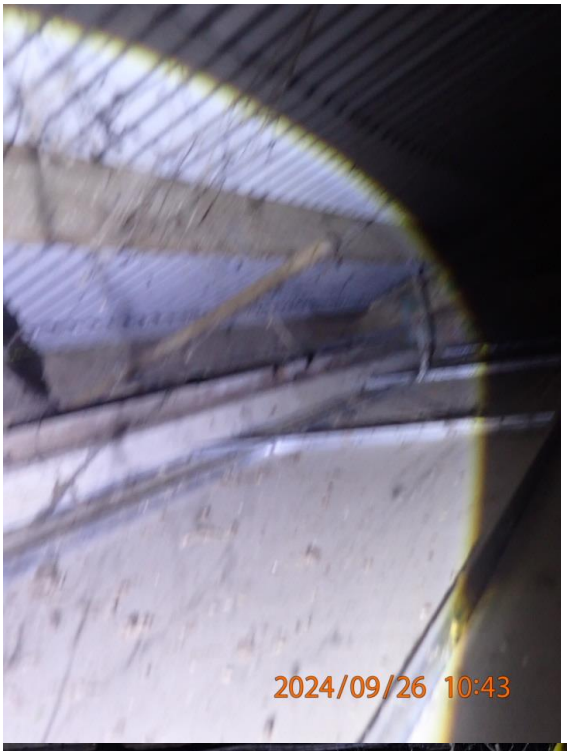
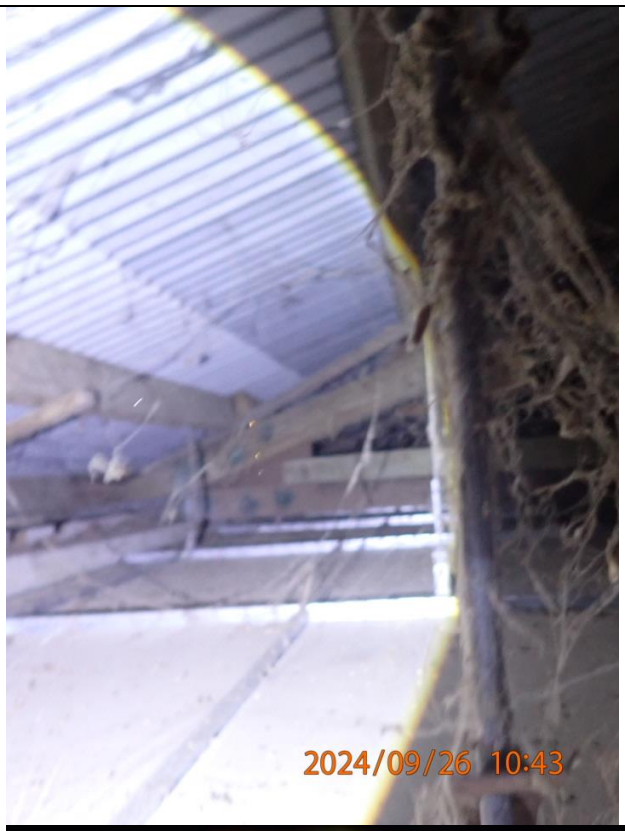
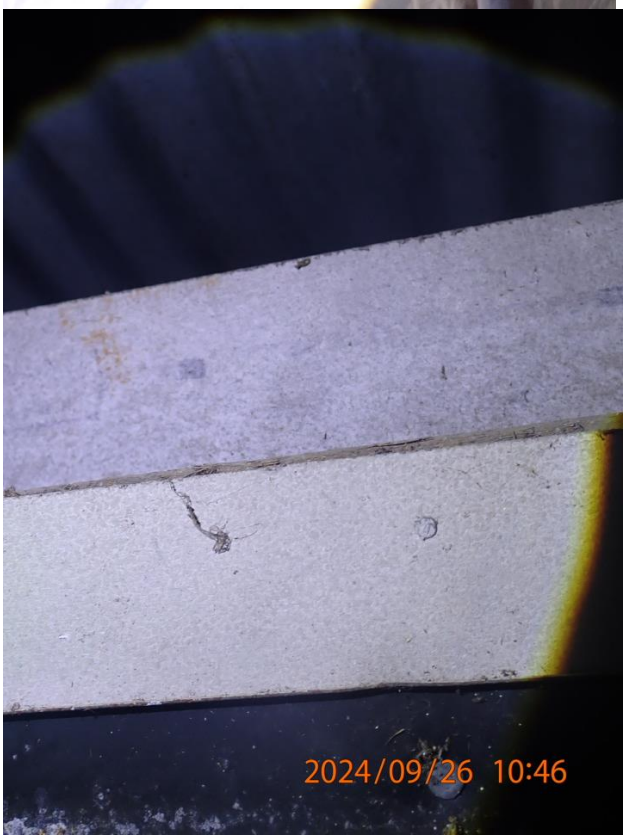
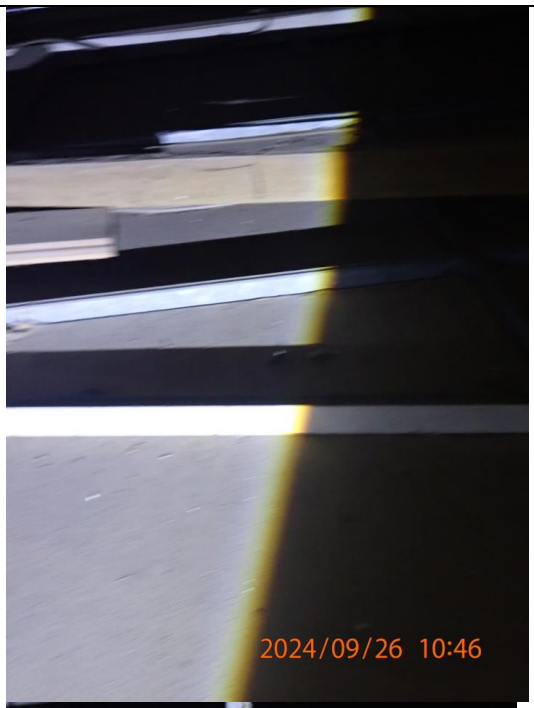
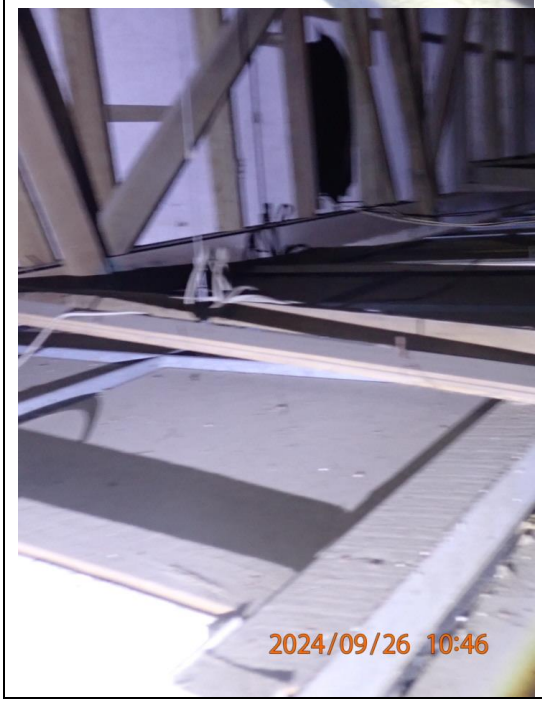
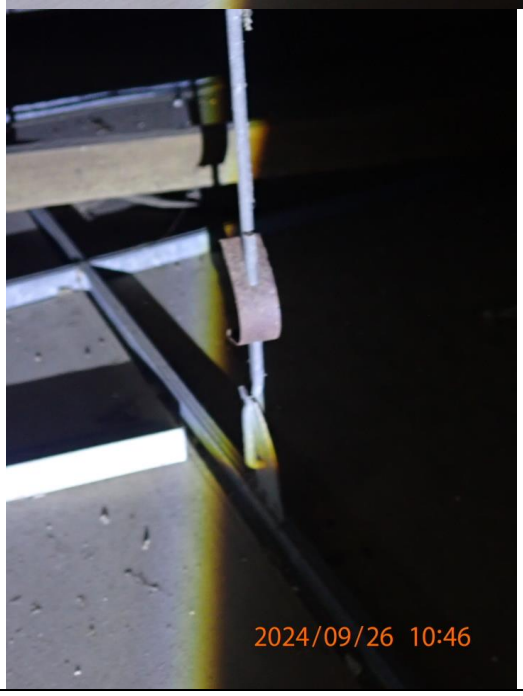
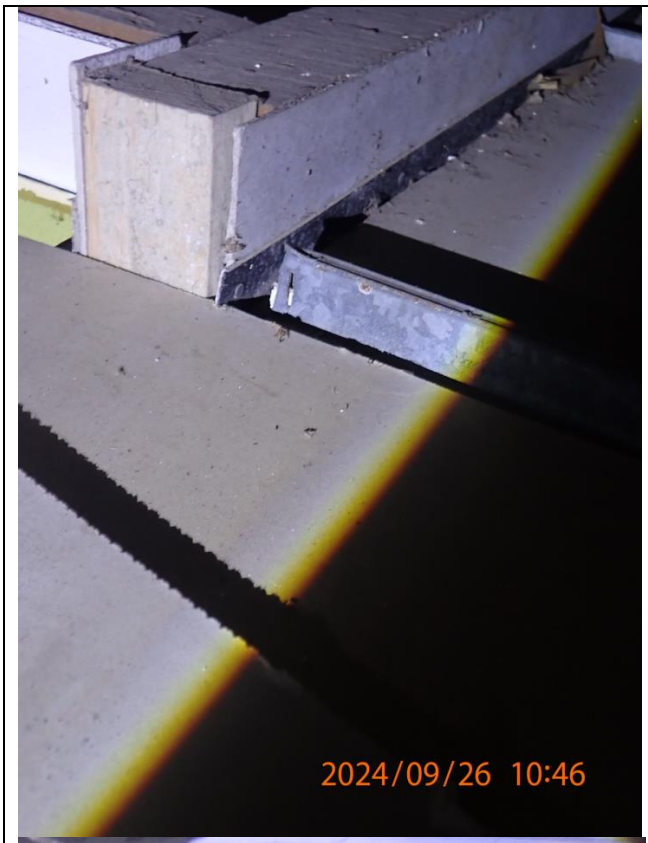
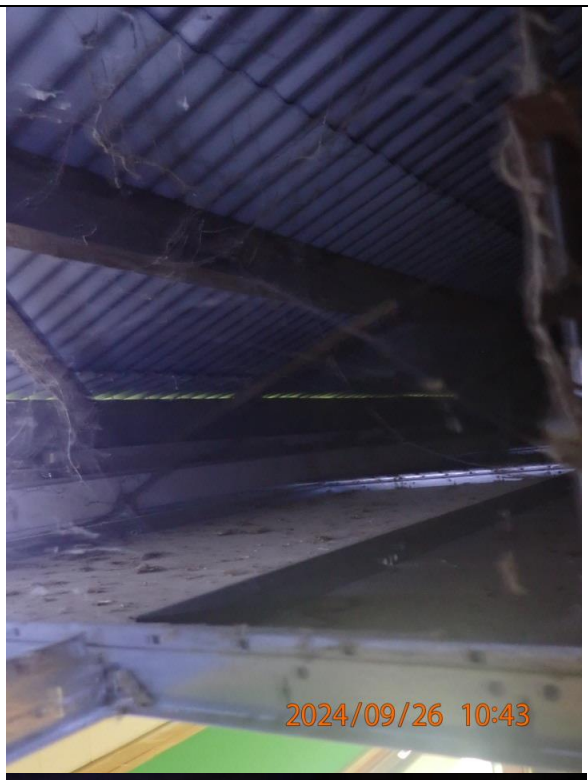
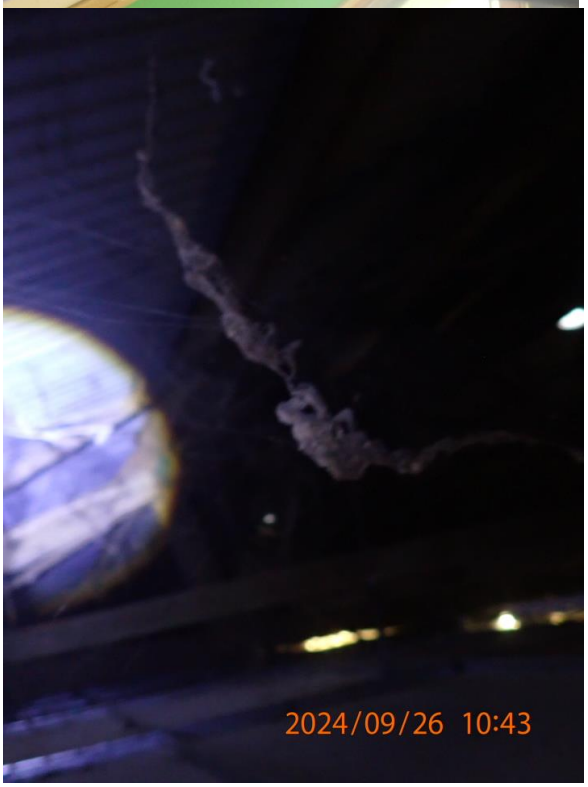
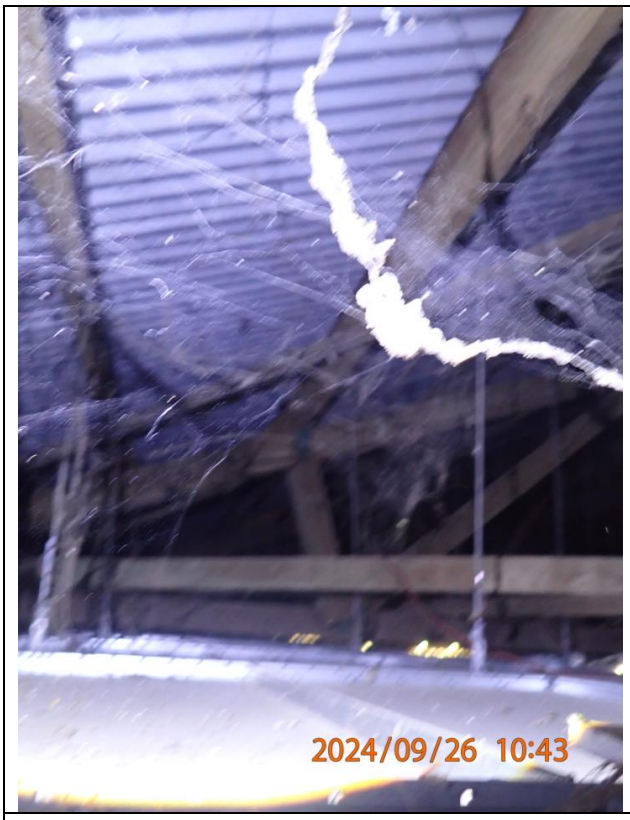
Building House Interior	Comment
Roof structure ***(visual only)*** *Due to possible deterioration, we are not able to advise the condition of metal or timber roof battens under roof insulation or roof sheeting and, not able to advise if insulation has been installed as per manufacturer specifications.* *as per* ***AS 4349.1.07*** 	• Defect: all roof structure Appears in an acceptable condition.

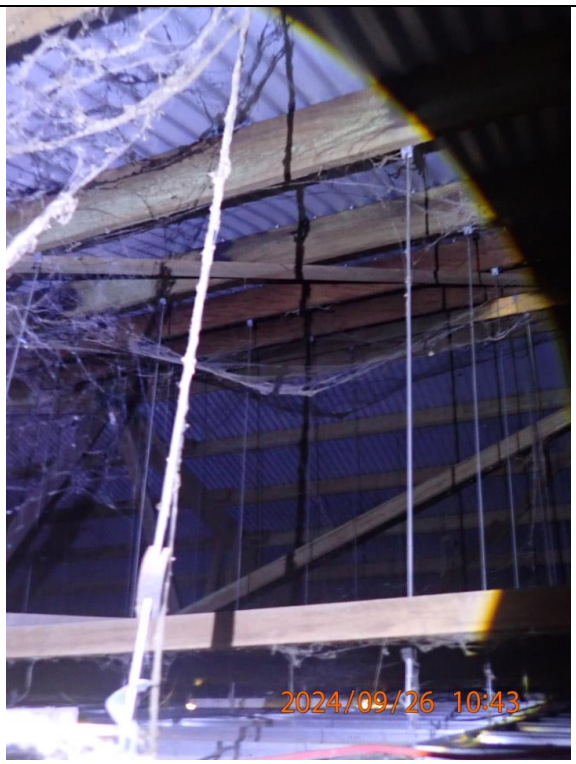
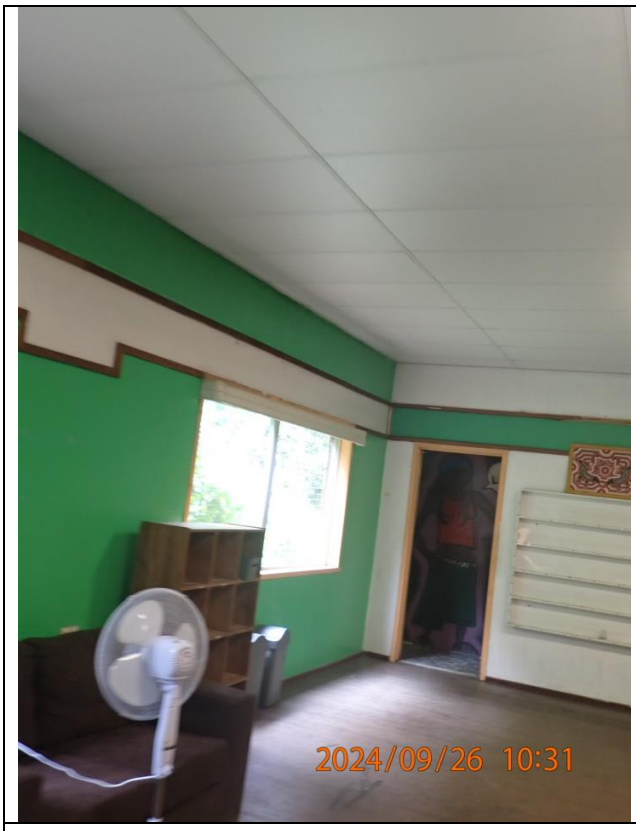
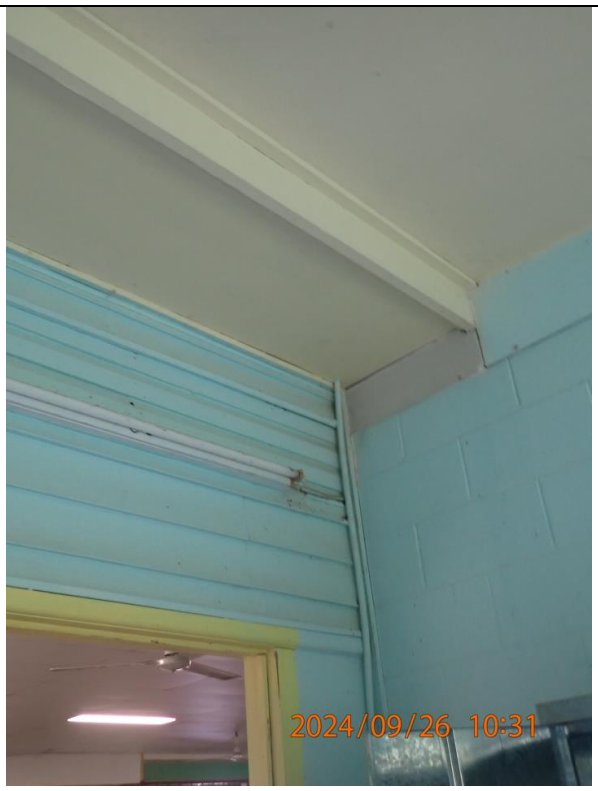
Ceiling lining

- Defect: defective and damaged ceiling panels and many recommended to be replaced as many have been wet and have deteriorated and may fall.

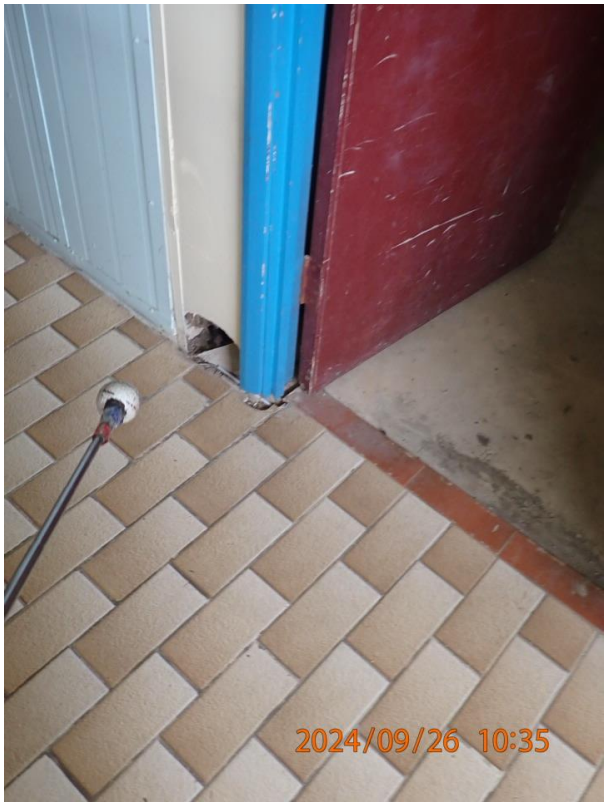
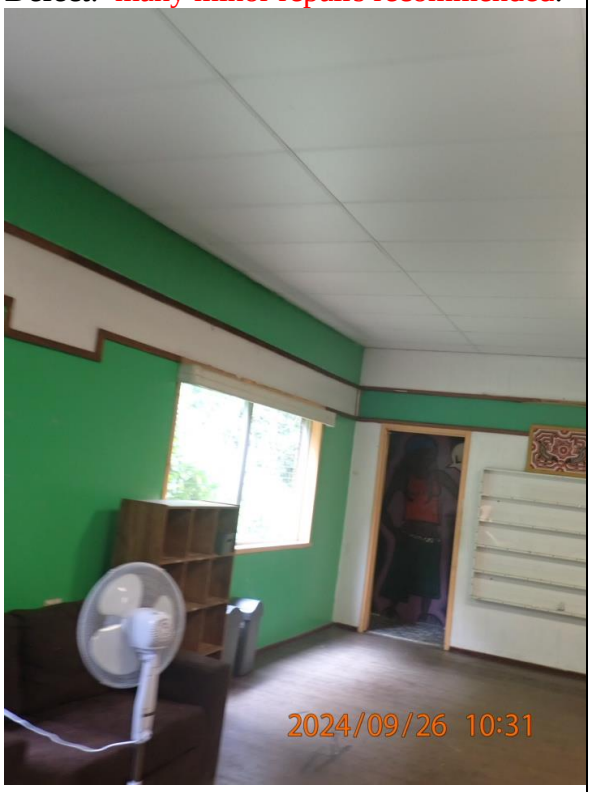
Internal walls

- Defect: many minor repairs recommended.

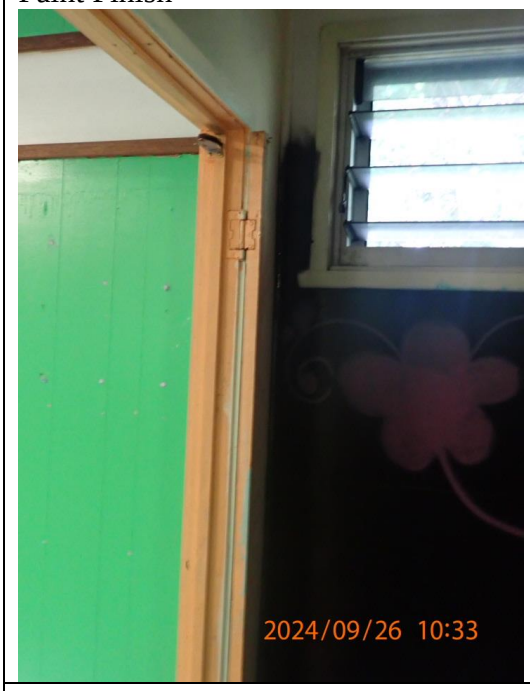
Paint Finish

• Defect: fair • Location: all • Recommendation: repaint
Floor and Coverings

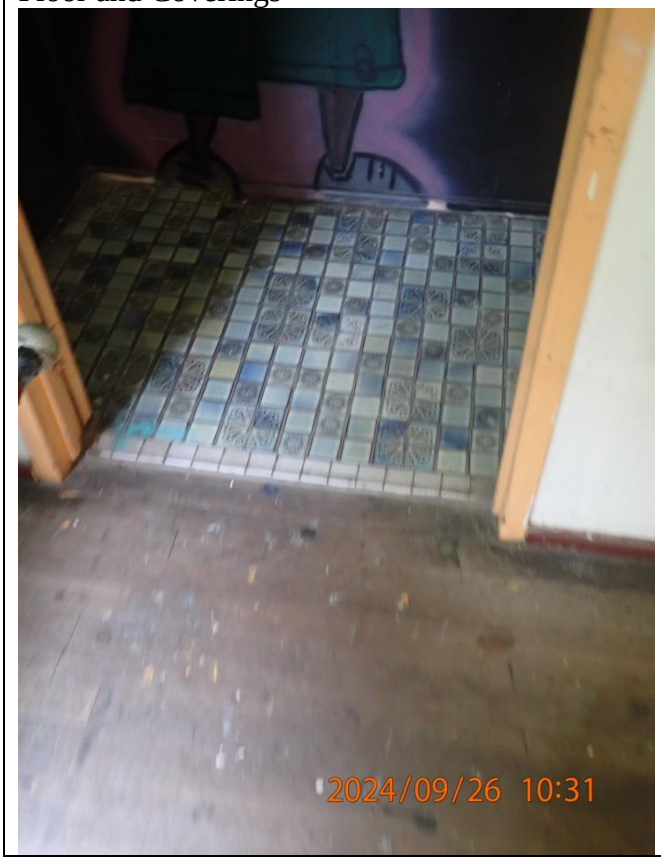
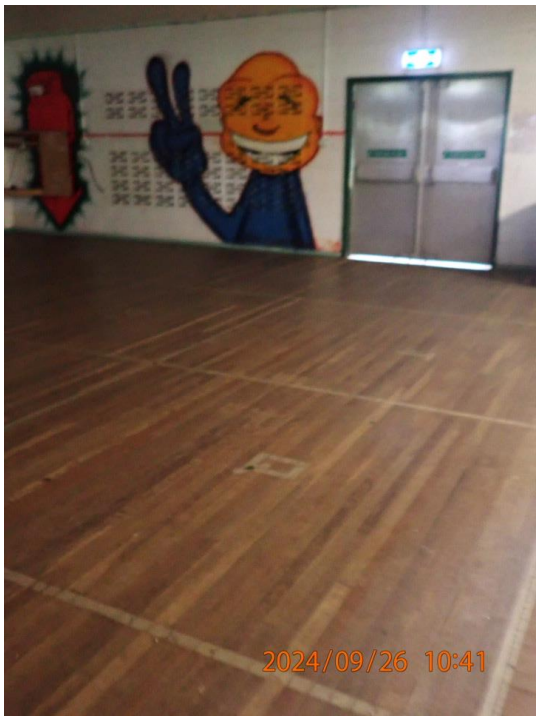
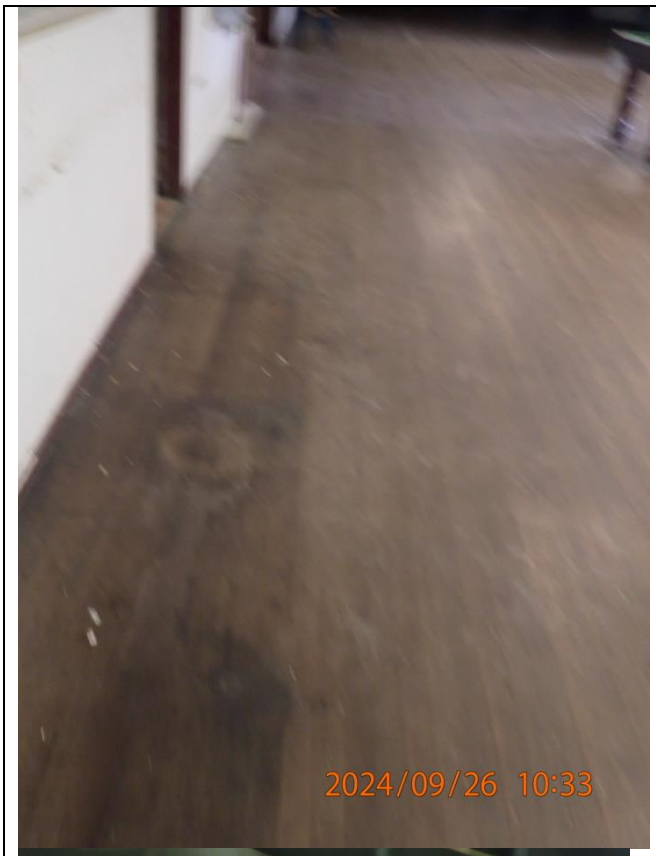
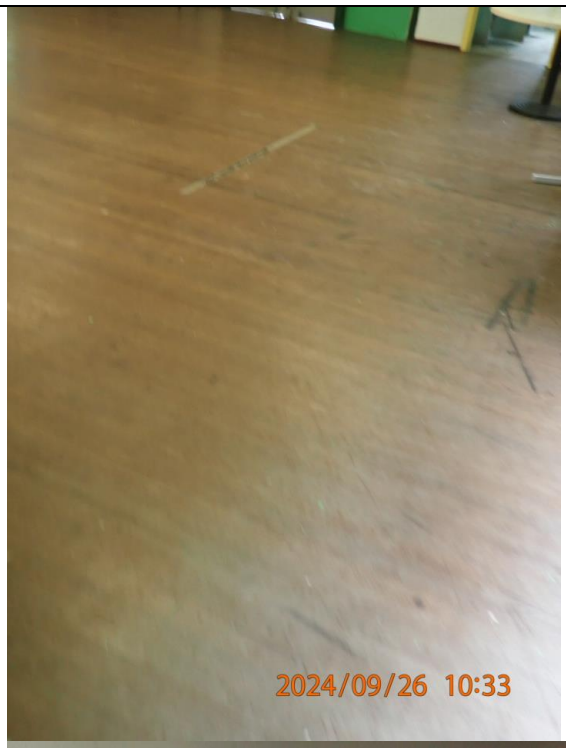
• Several drum tiles to all wet areas

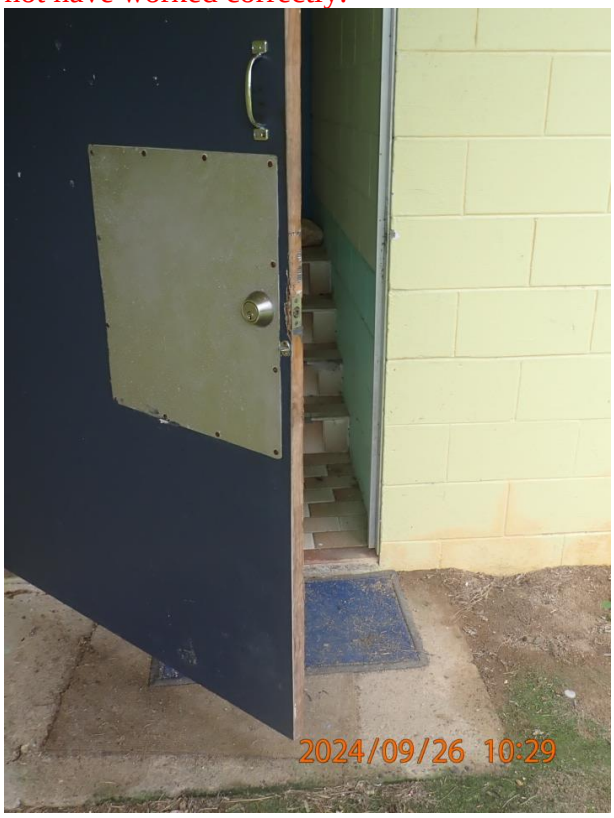
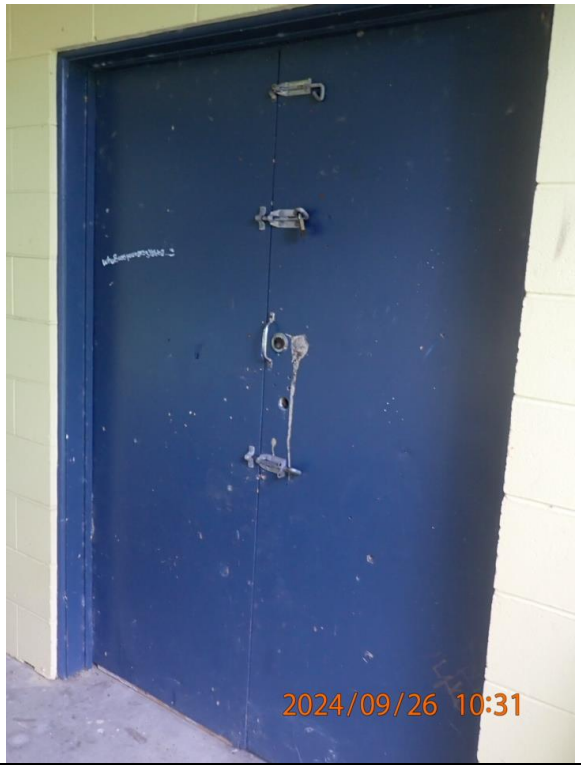
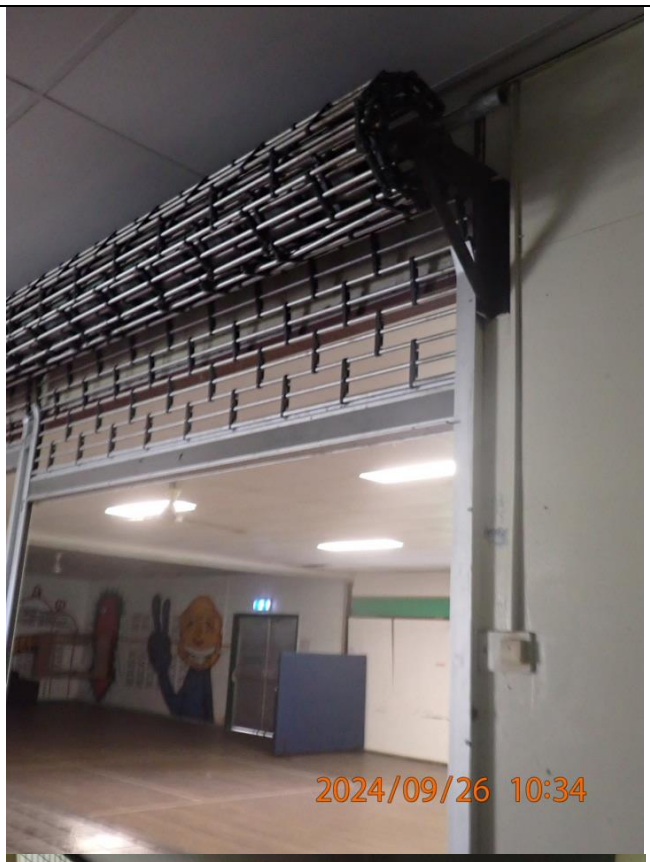
- **Defect**: minor repairs recommended. all roller doors and to bar need to be repairs, hard to roll.
- **Recommendation**: **Carpenter** – engage a suitably qualified carpenter for rectification advice in accordance with A1684.2

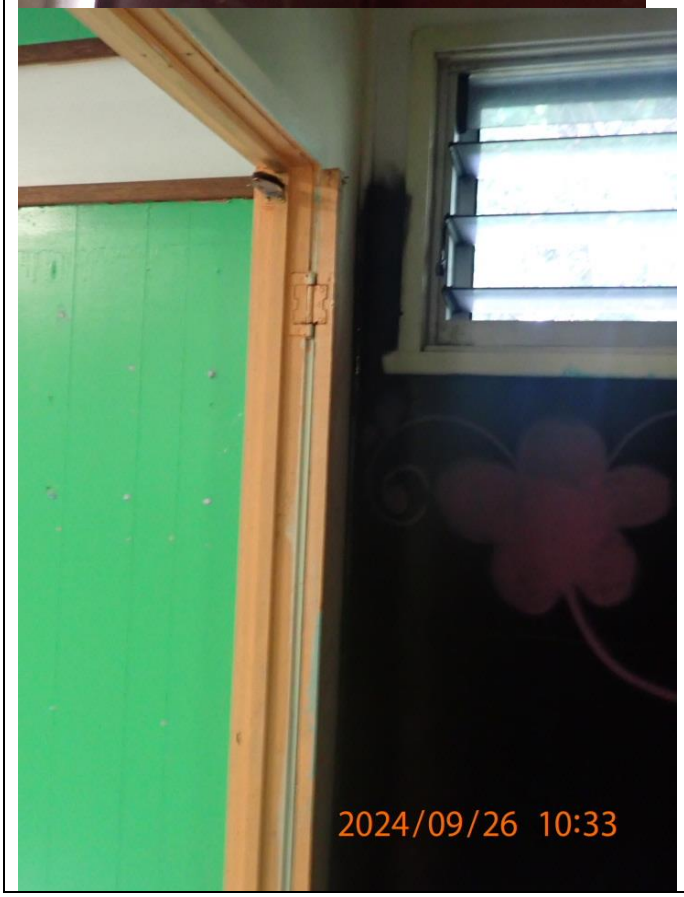
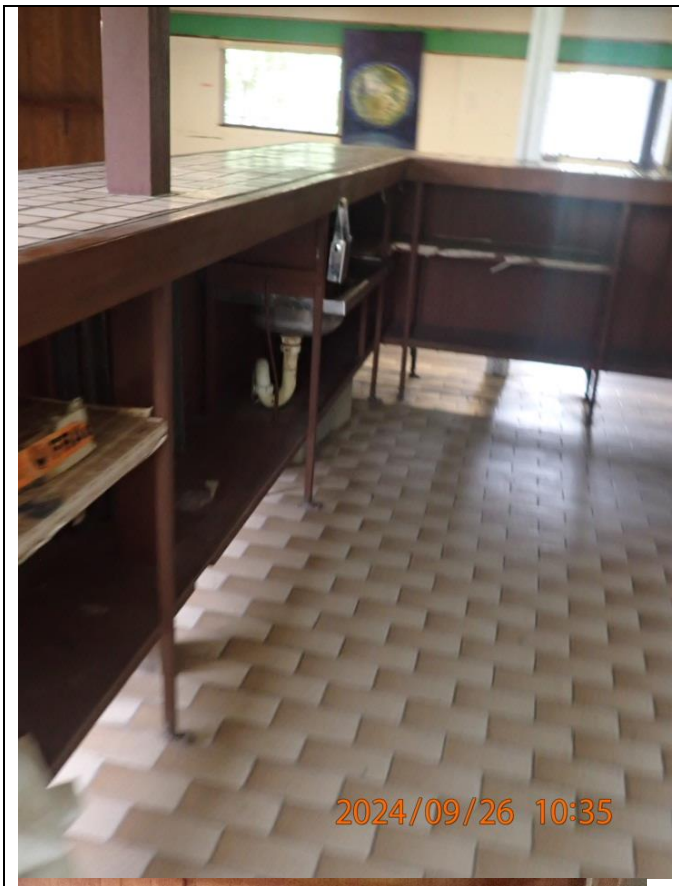
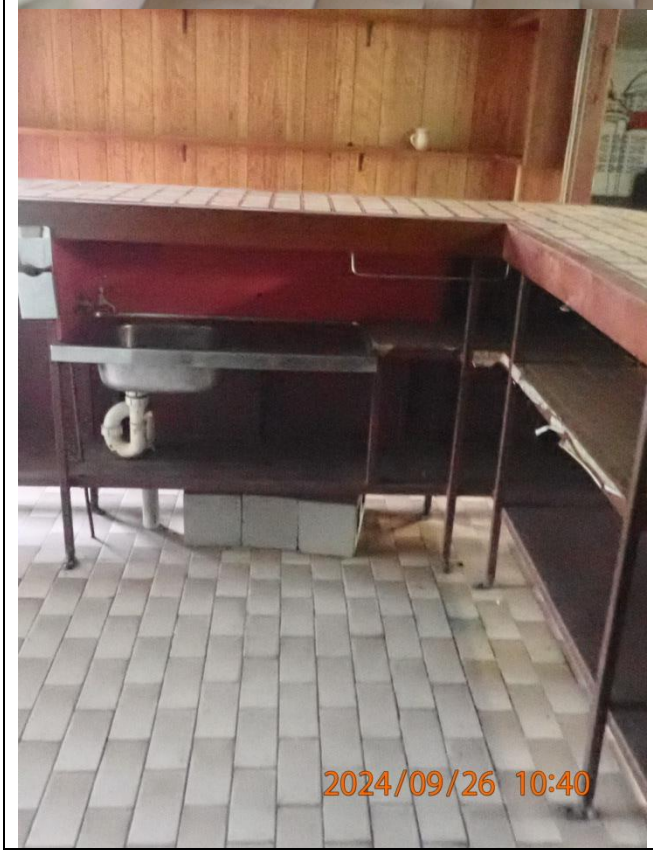
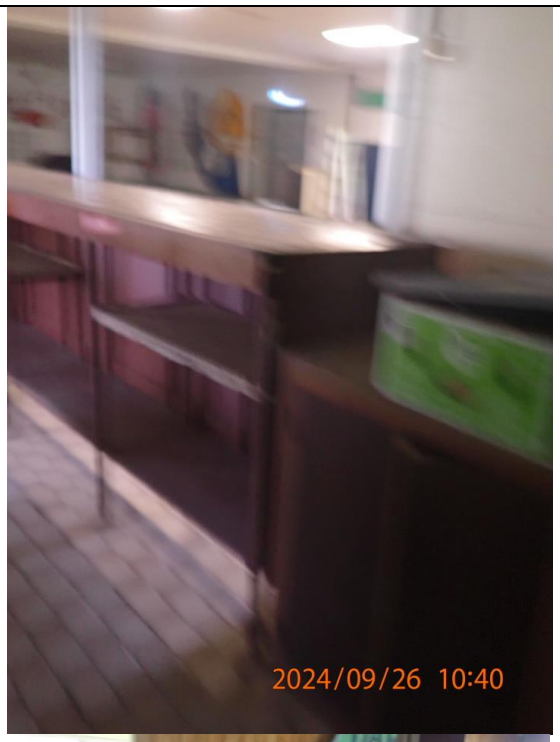
Window Recommend regular maintenance of sliding window tracks and rollers to prevent seizing. 	• **Defect**: rust to lover frames and areas of rot or pest damage to several window deterioration and repairs are recommended. • **Recommendation: Carpenter** – engage a suitably qualified carpenter for rectification advice in accordance with A1684.2
Bar Area 	• **Repairs to all roller door recommended.** repairs to bar area are recommended. bar

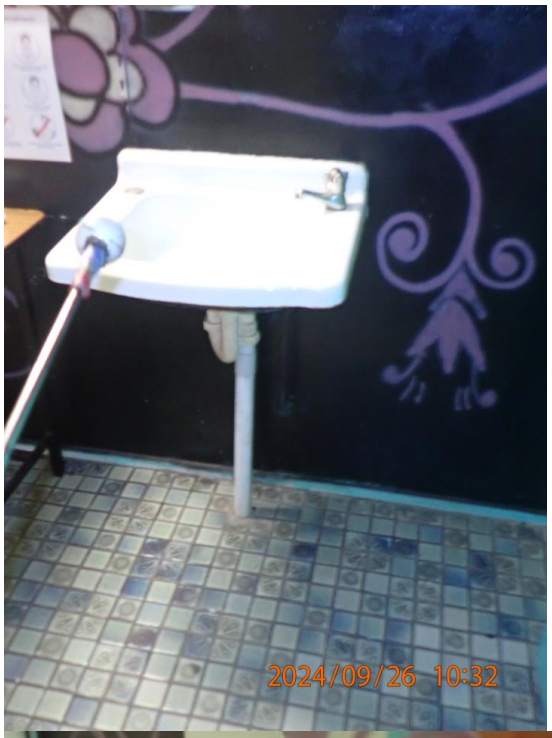
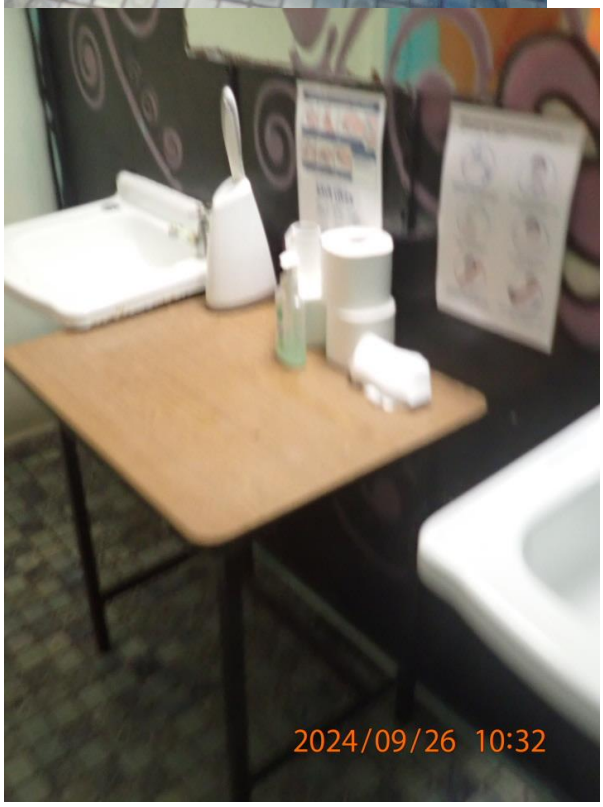
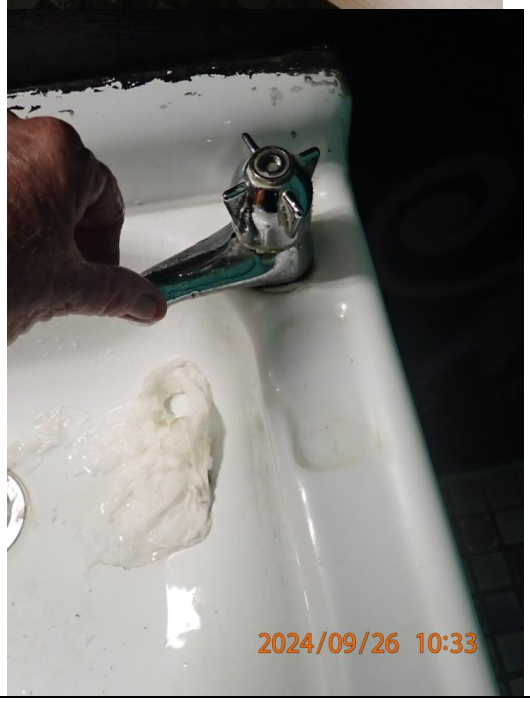
Building Interior Wet Areas	Comments
Bathroom 1 –

• All bathrooms are in a fair/ acceptable condition with repairs recommended. broken taps and toilet systems • Recommend replacement of all sealants as preventative maintenance when required.
