Confidential Property Report

A.C.C.S. PROPERTY INSPECTIONS

Tax Invoice: *2289*
CLIENT **Mandy Larsen**
PHONE: **0439 368079**
EMAIL: ***mandy/laesen@ccrc.qld.gov.au***
POSTAL ADDRESS
PROPERTY: **Mullens Hall Tully Showgrounds**
DATE: **26th September 2024**
WEATHER: **Fine**

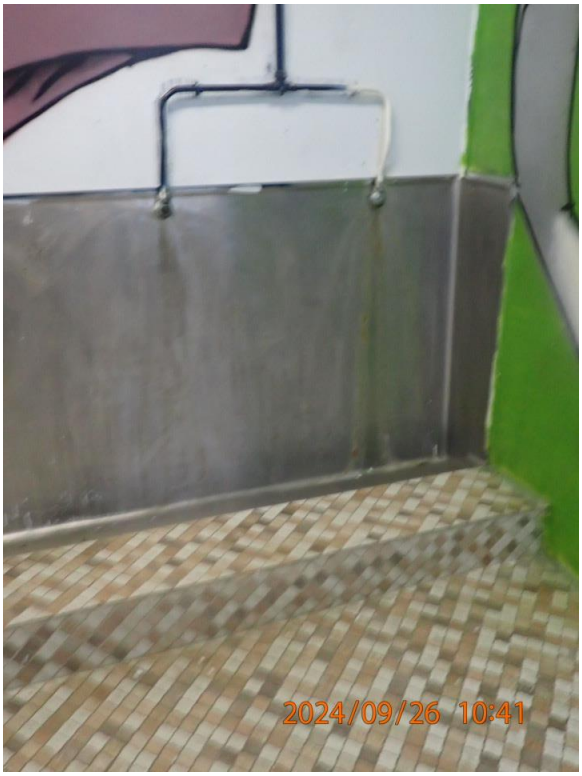
Bathroom 2 	Same as above

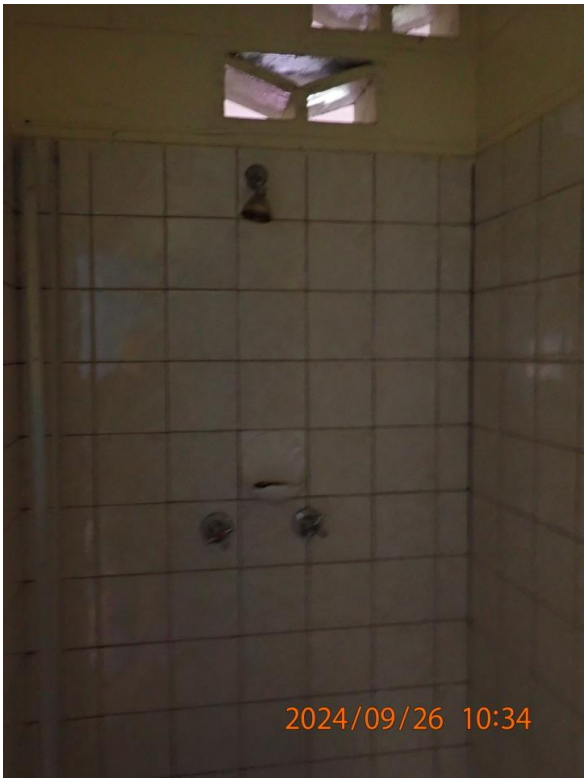
Bathroom 3 	As above

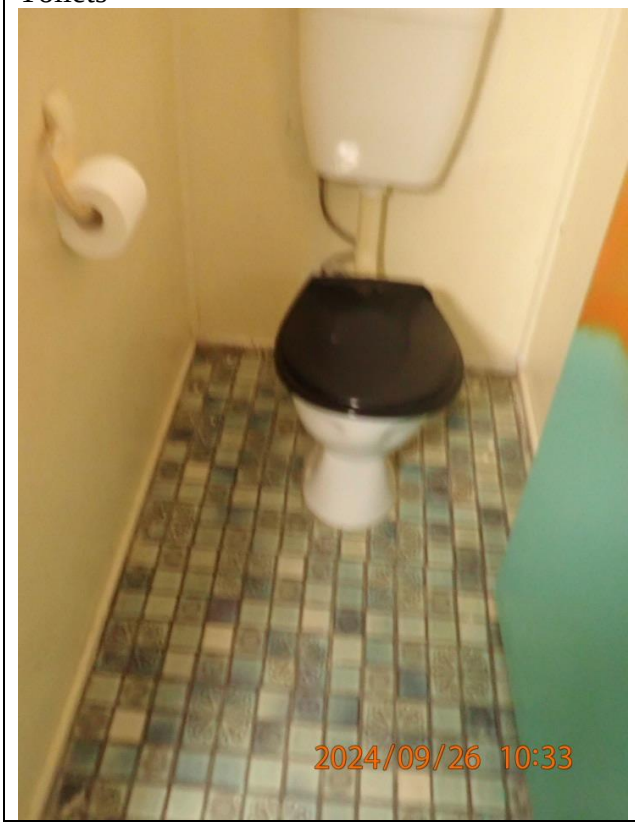
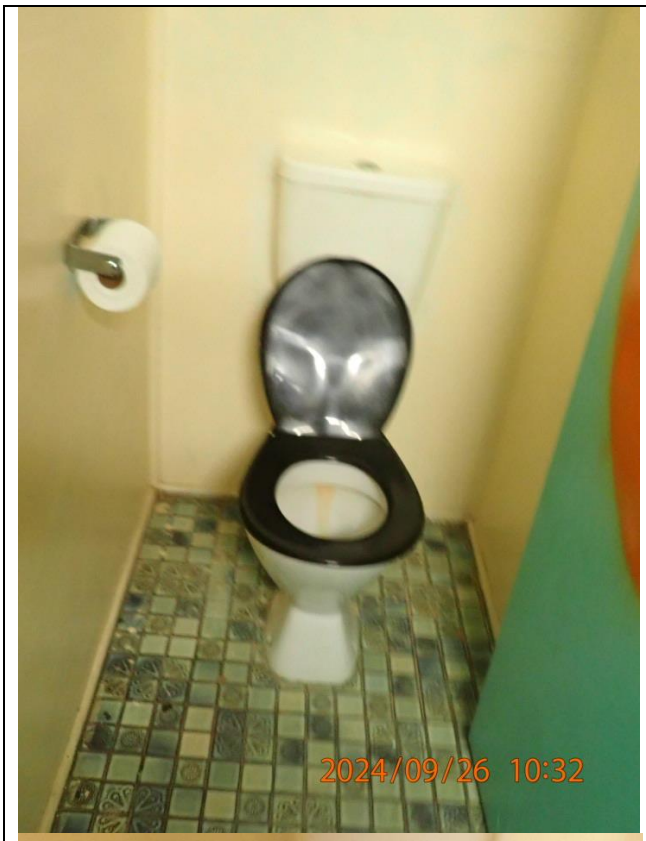
Toilets –

• Generally, appears to be in a fair condition. • Repairs are recommended. • Recommend replacement of all sealants as preventative maintenance when require

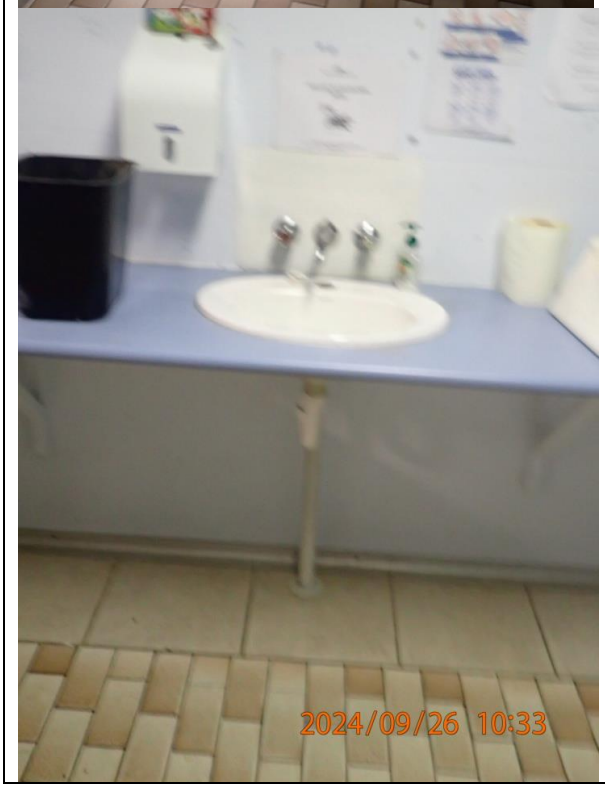
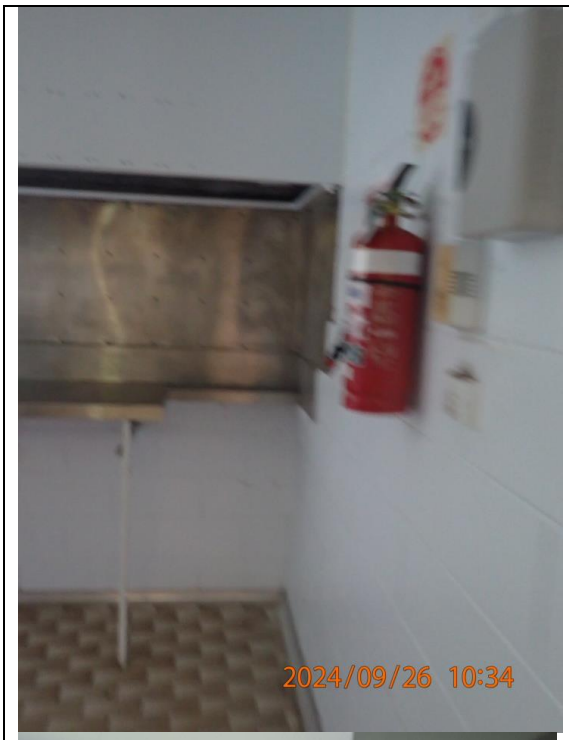
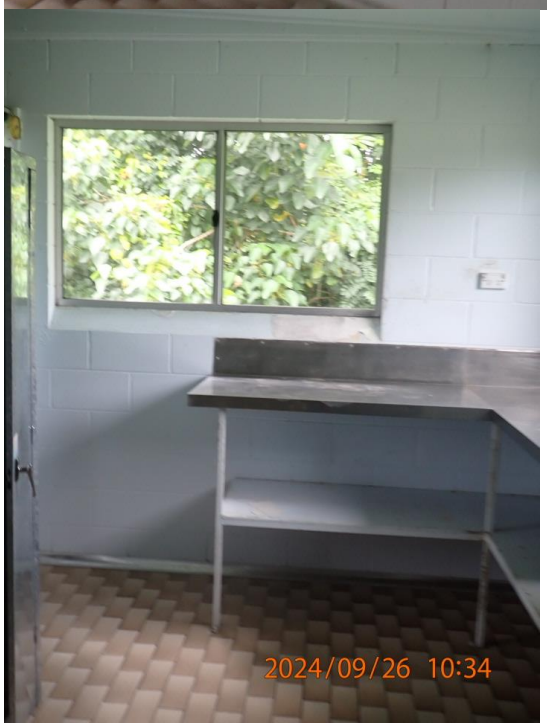
Kitchen 1 – NOTE WE DO NOT CHECK ANY ELECTRICAL ITEMS OR APPLIANCES

• No defects or safety hazards found. • Generally, appears to be in a Fair / acceptable condition repairs and cleaning is recommend. No appliance or cool rooms were operated. • Recommend replacement of all sealants as preventative maintenance when required.

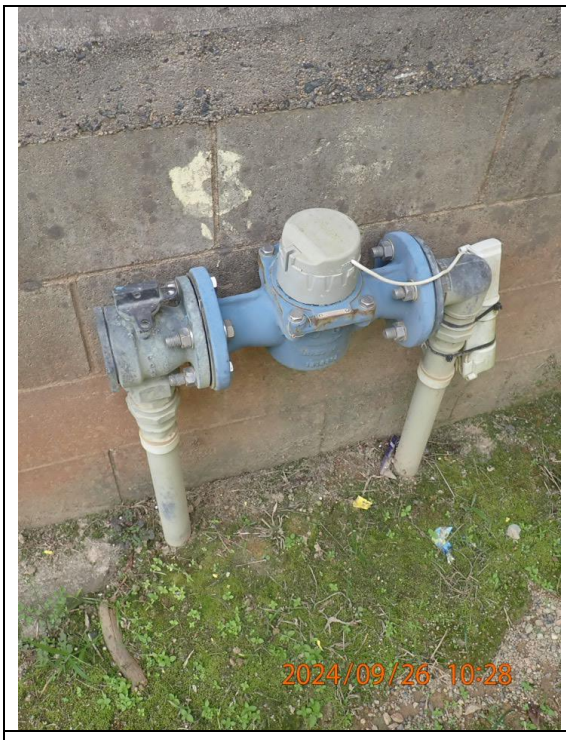
Misc. Items	Comments
Plumbing (Interior) *Note: ACCS inspectors are not qualified plumbers. For a comprehensive report, a plumbing inspection on all underground septic and sewerage systems is recommended. Recommend council be consulted to confirm all existing serviced are as per present by laws is recommended.*	Minor repairs recommended.
Plumbing (Exterior) *Note: ACCS inspectors are not qualified plumbers. For a comprehensive report, a plumbing inspection on all underground septic and sewerage systems is recommended. Recommend the council be consulted to confirm all existing services are as per present by laws is recommended.*	• Defect: leaking drainpipe and needs to be repaired.
